Aircraft Structures Report 449

**DAMAGE TOLERANCE ASSESSMENT OF BORON/EPOXY
REPAIRS TO FUSELAGE LAP JOINTS**

D. REES
L. MOLENT
R. JONES

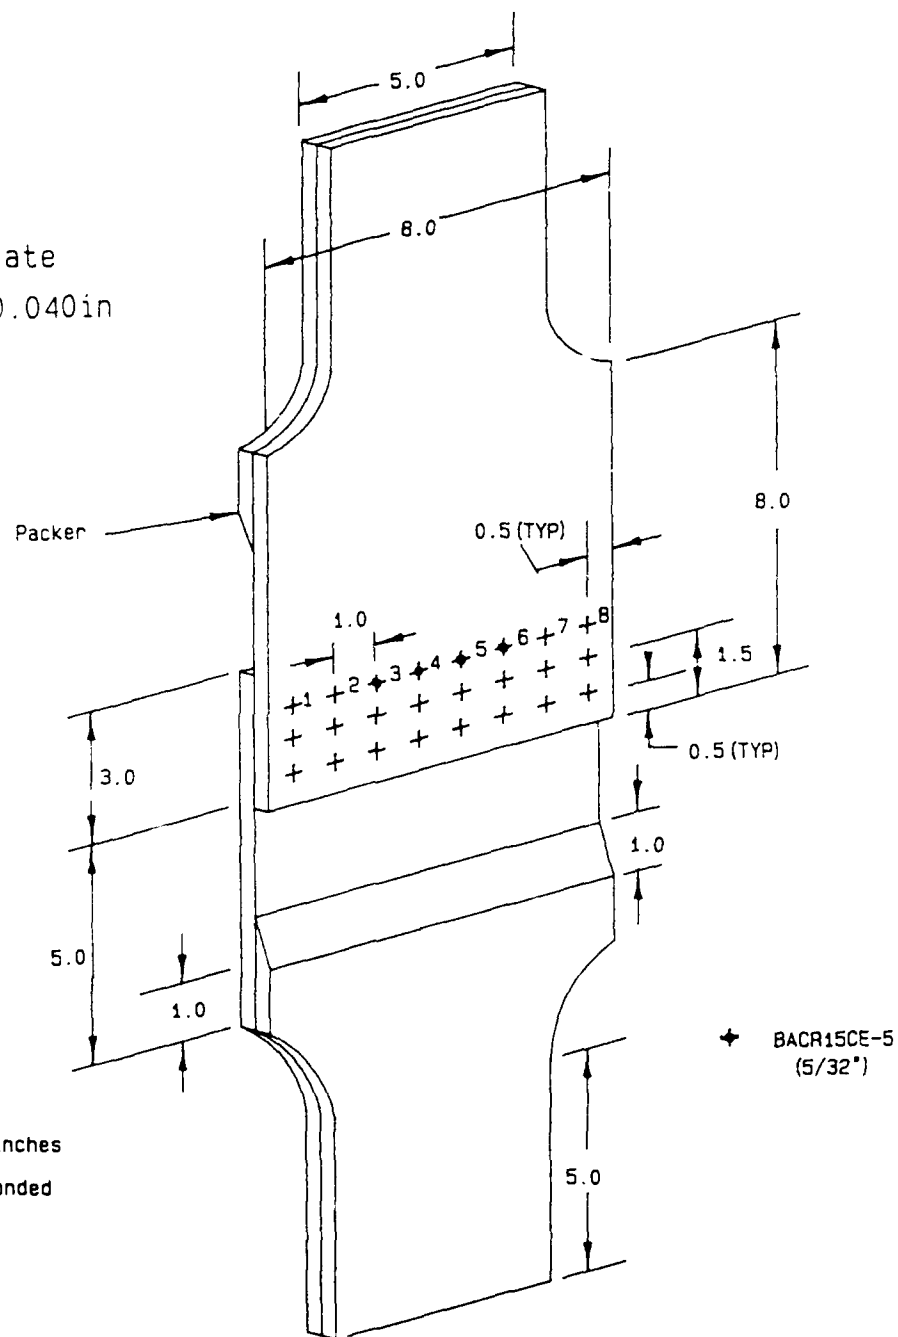
Figure 1. Fuselage Lap Joint Specimen

2024-T3 Plate
Thickness=0.040in

Dimensions in inches
Packer to be bonded

The lap joint specimens consisted of two 1.016mm thick 2024-T3 aluminium sheets fastened with three rows of 3.97mm diameter BACR15CE-5 100° shear head counter sink rivets. Specimen dimensions are shown in Figure 1. To reproduce crack growth rates in agreement with fleet measurements [2], the specimens were assembled in pairs by bonding back to back on a 12.5mm thick honeycomb core. Multiple cracks in the upper row of rivets were initiated and grown under a tensile fatigue loading. The specimens were then repaired using a 203mm long by 203mm wide unidirectional boron/epoxy doubler. Details of specimen manufacture, crack initiation, crack growth rates and further details of the repair can be found in previous reports [1,2].

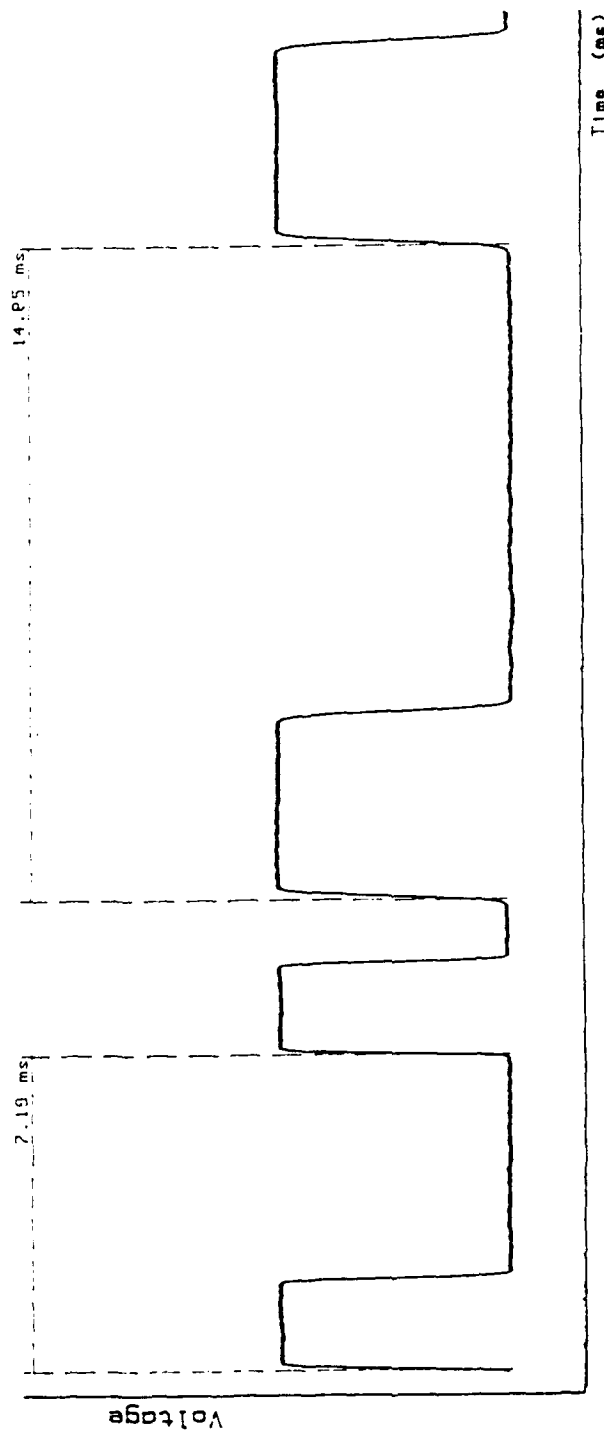
Figure 5. Typical Impact Test Result

IMPACT TEST PLOT

Absorbed Energy = 3.6524 Joules.

A typical impact test result is shown in Figure 5. The impact site locations are shown in Figure 6, and the impact energies are summarised in Table 2.
